BACK TO THE FUTURE

Time, neglect and saltwater have all had their impact on the swing bridge at Folkestone harbour, but after extensive repair works it is now ready for use again, albeit as a pedestrian walkway across the inner harbour

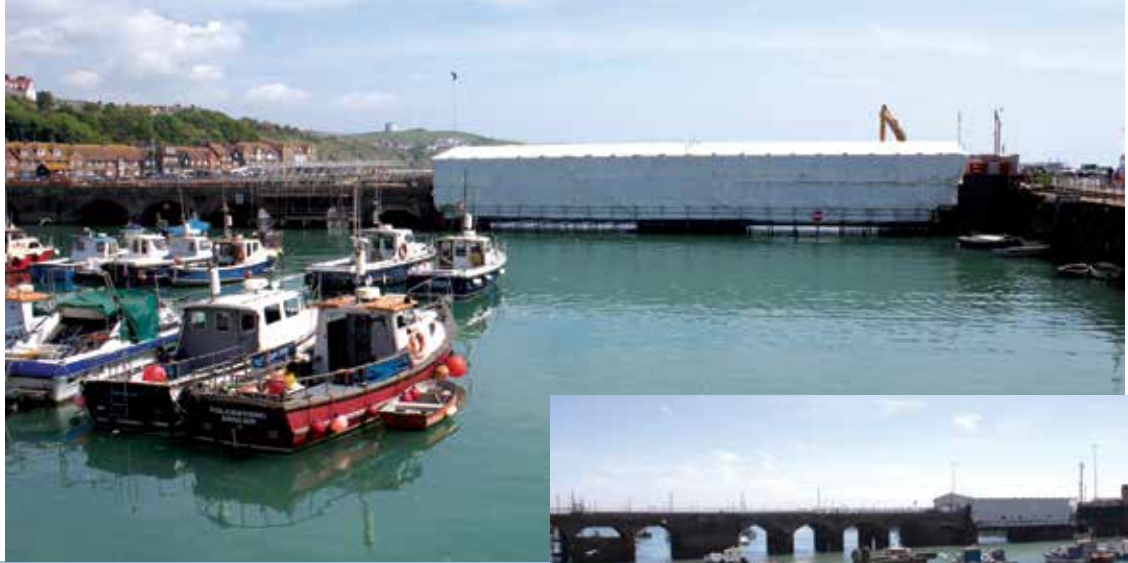
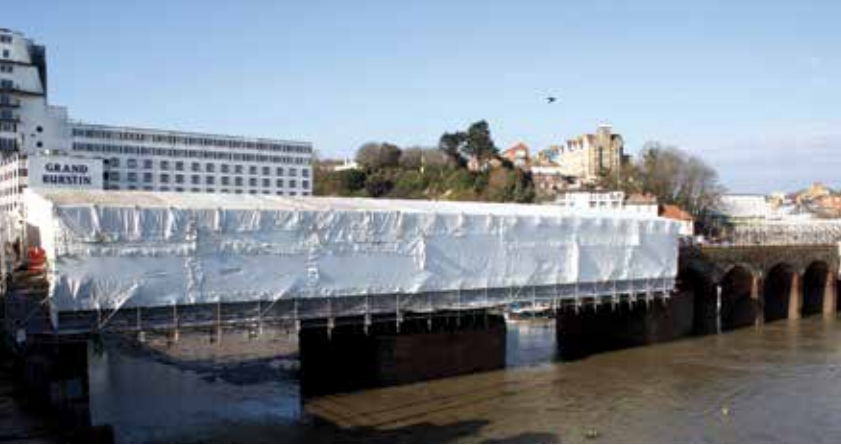
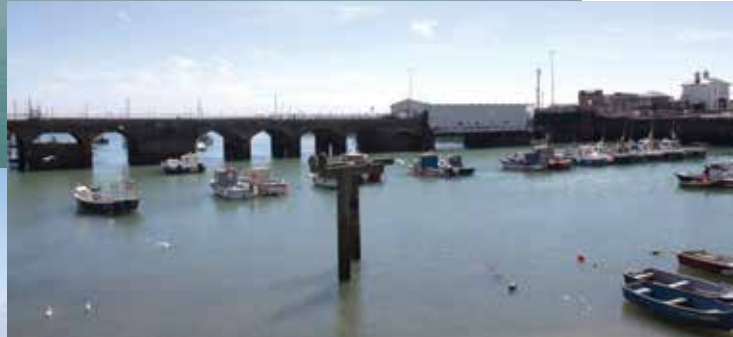
Repointing the brickwork and blastcleaning the steel took over 20,000 man hours

Time, neglect, salt-water and weather combined to make the restoration job a challenge. Decay on the two parts of the harbour crossing – a thirteen-arch brick viaduct and the steel swing-bridge – was so severe that repointing the brickwork and blastcleaning the steel took over 20,000 man hours. Despite the extent of work, the viaduct will be open to pedestrians later this year as further work on redevelopment continues.

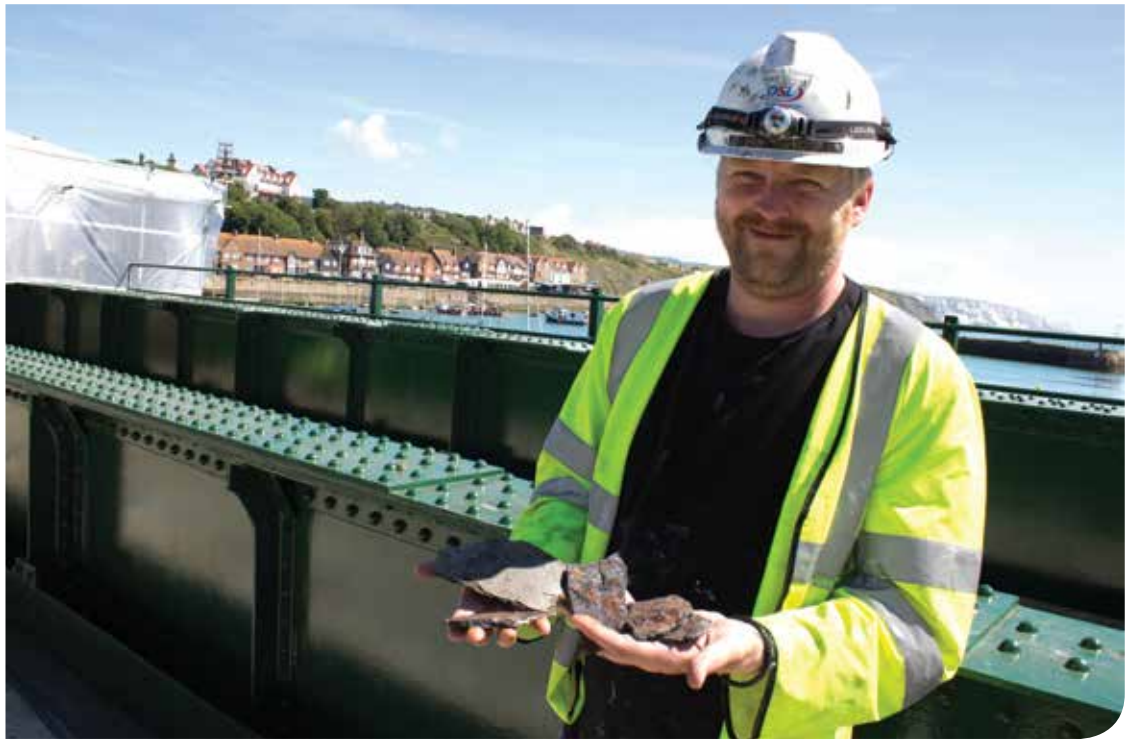
Right: Large quantities of rust and scale have been removed

"Over 12000 man hours have been expended on the swing bridge to date. Large quantities of rust and scale have been removed. We used an Edcar 22KW dust extraction and ventilation unit to control dust and provide a safe and comfortable environment for blast operatives. We also used a Sacvac vacuum recovery unit to extract spent abrasive from the bridge back to the quayside for removal and disposal."

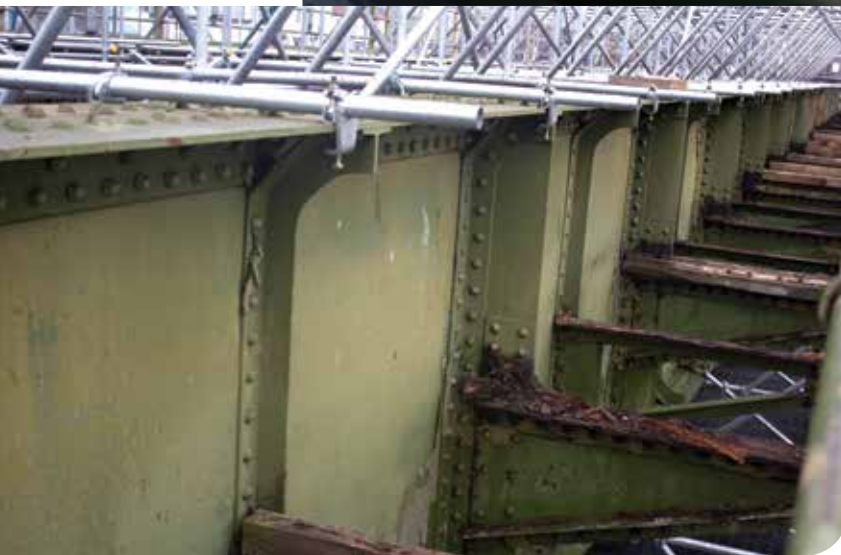
Above: Over 400 individual steel repairs were completed by a team of up to six welders

Over 400 individual steel repairs were completed by a team of up to six welders from a local company, Cook Fabrications Ltd.
